PRO.SIS.TEL.

Produzione Sistemi Telecomunicazioni
Antenna rotators - Towers

Mechanical fuse fixing/restoring

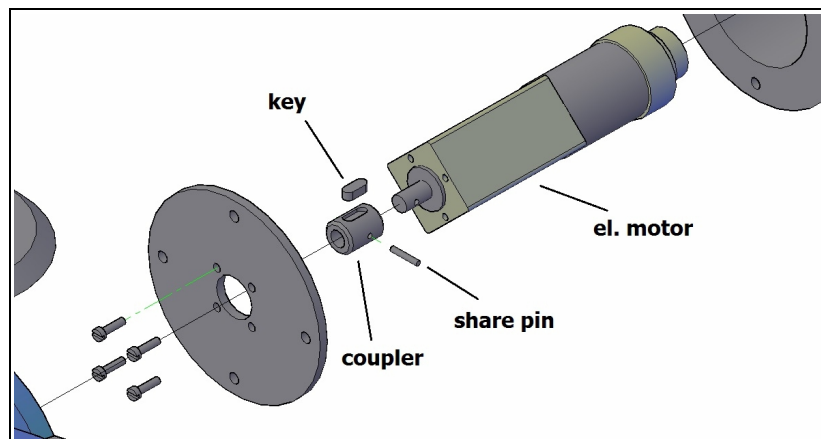
Let us explain: the motor with the first gearmotor stage are joined to the main rotator body with a steel coupler, such cylinder is stopped on there with a pass through pin, such pin protect the motor and his gearbox from possible damages in case that for somehow the rotator shaft get stopped due external forces. It is a safety device that works like a fuse protecting the motor and the first gearmotor stage. In other words better to break such pin which cost few cents and is easily replaceable because available in any mechanical parts shop than not to destroy the motor and his gearbox that cost much more and is available only here.

This kind of safety device solution is used in many expensive industrial machinery, where is better to have a pin broken than not a larger damage due overload.

The frequency of this issue is less than 1% but happens and if happens means that something stopped antenna for a while (very often wind), so the motor go in overload, if overload time became too long, the motor delivery enough power to break the pin.

What is the solution? Replace it with a new one.

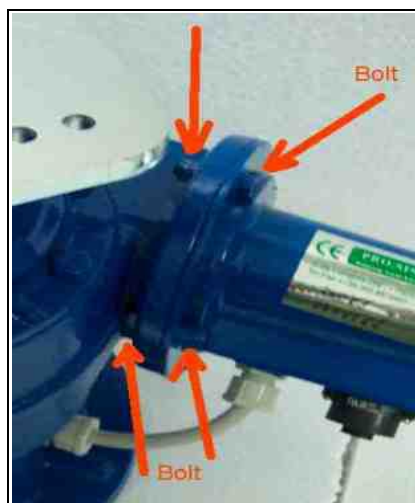
Unscrew the bolts and using a cutter share the motor cover body from the rotator body.

PST61 don't have external cable, for which pay attention using the cutter, do not damages inner wires.

If the grey cable is too short, release a bit the plastic nut from the rotator base side and pull the cable out for few centimeters.

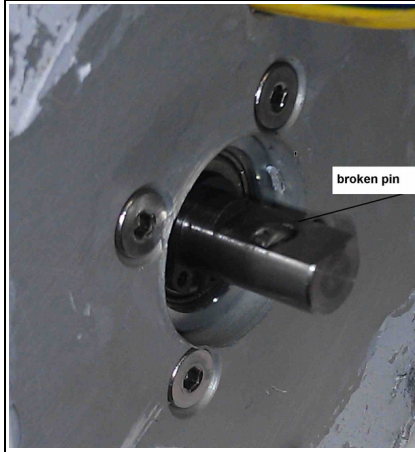
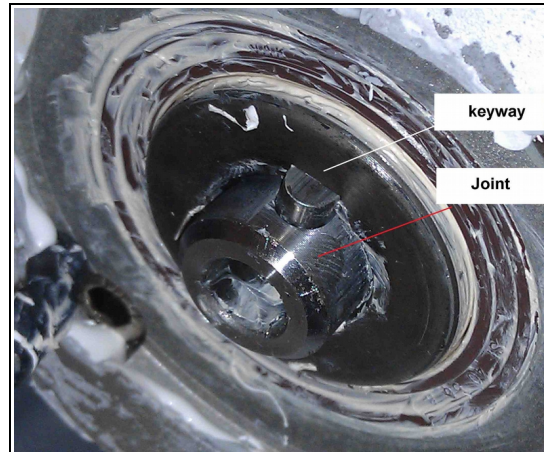
When the motor cover come out you may have the coupler cylinder still on the motor shaft or on the main rotator side (see the picture below).

In this case use a hook or a player to pull it out.

Using a 3mm rod tool, push out the rest of the pin from the motor shaft and from the cylinder, get a new pin (3mm x 18mm flexible version, they are available in any mechanical shop, in stainless steel or black steel, the black steel is stronger and more easy to find) if you get a longer one, than just cut away the extra length. If you get difficulties to fit in the cylinder hole the new flexible pin, than using a player just reduce one pin end diameter for a couple of millimeters making it conical, this will help the entry way in the cylinder hole, after than you need a small hammer to push it down.

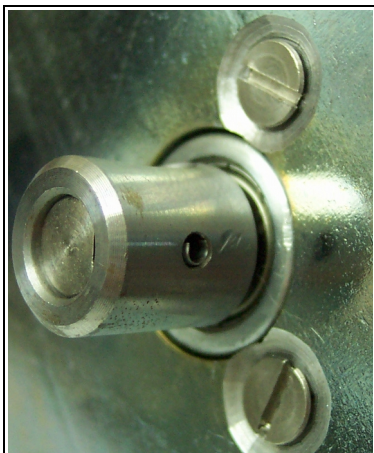
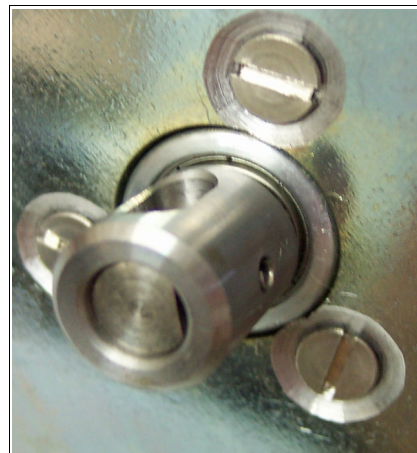
When done it will looks like the pictures below.

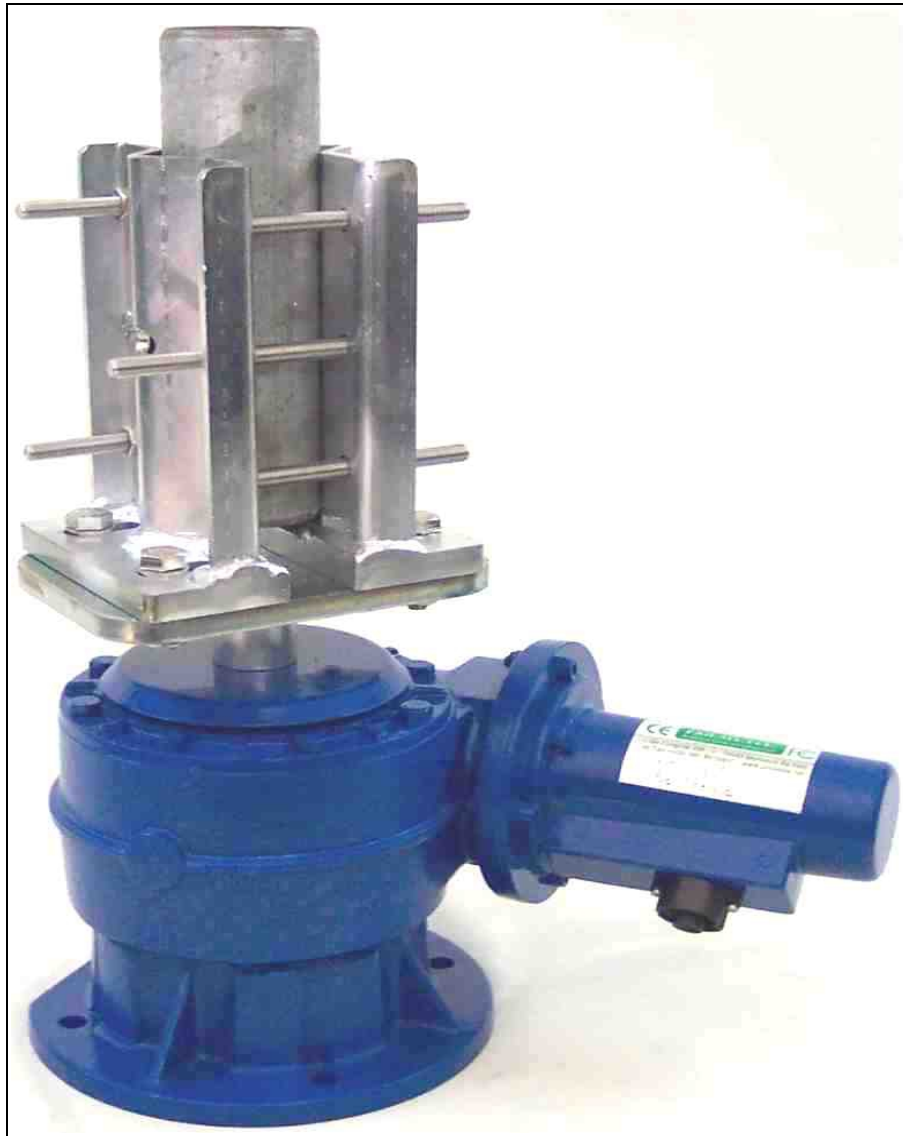
Reassembly the motor assy back, don't forget the keyway, put momentary bolts and check the rotator, if runs OK, remove the bolts, seal the motor cover against the rotator main body using polyuretane sealant or similar glue, screw down the bolts and clean the sealant that come out from the flanges. Make sure that the sealant fully cover the flanges border.

When sealant is dry, you may use blue spray to restore the original painting.
